**Subject:       Abbreviated Preliminary Assessment Checklist**  
**9540 Niagara Falls Boulevard**  
**Contract No.: EP-S5-06-04, TDD No.: S05-0013-1307-008**

## ABBREVIATED PRELIMINARY ASSESSMENT CHECKLIST

**Site Name:** 9540 Niagara Falls Boulevard

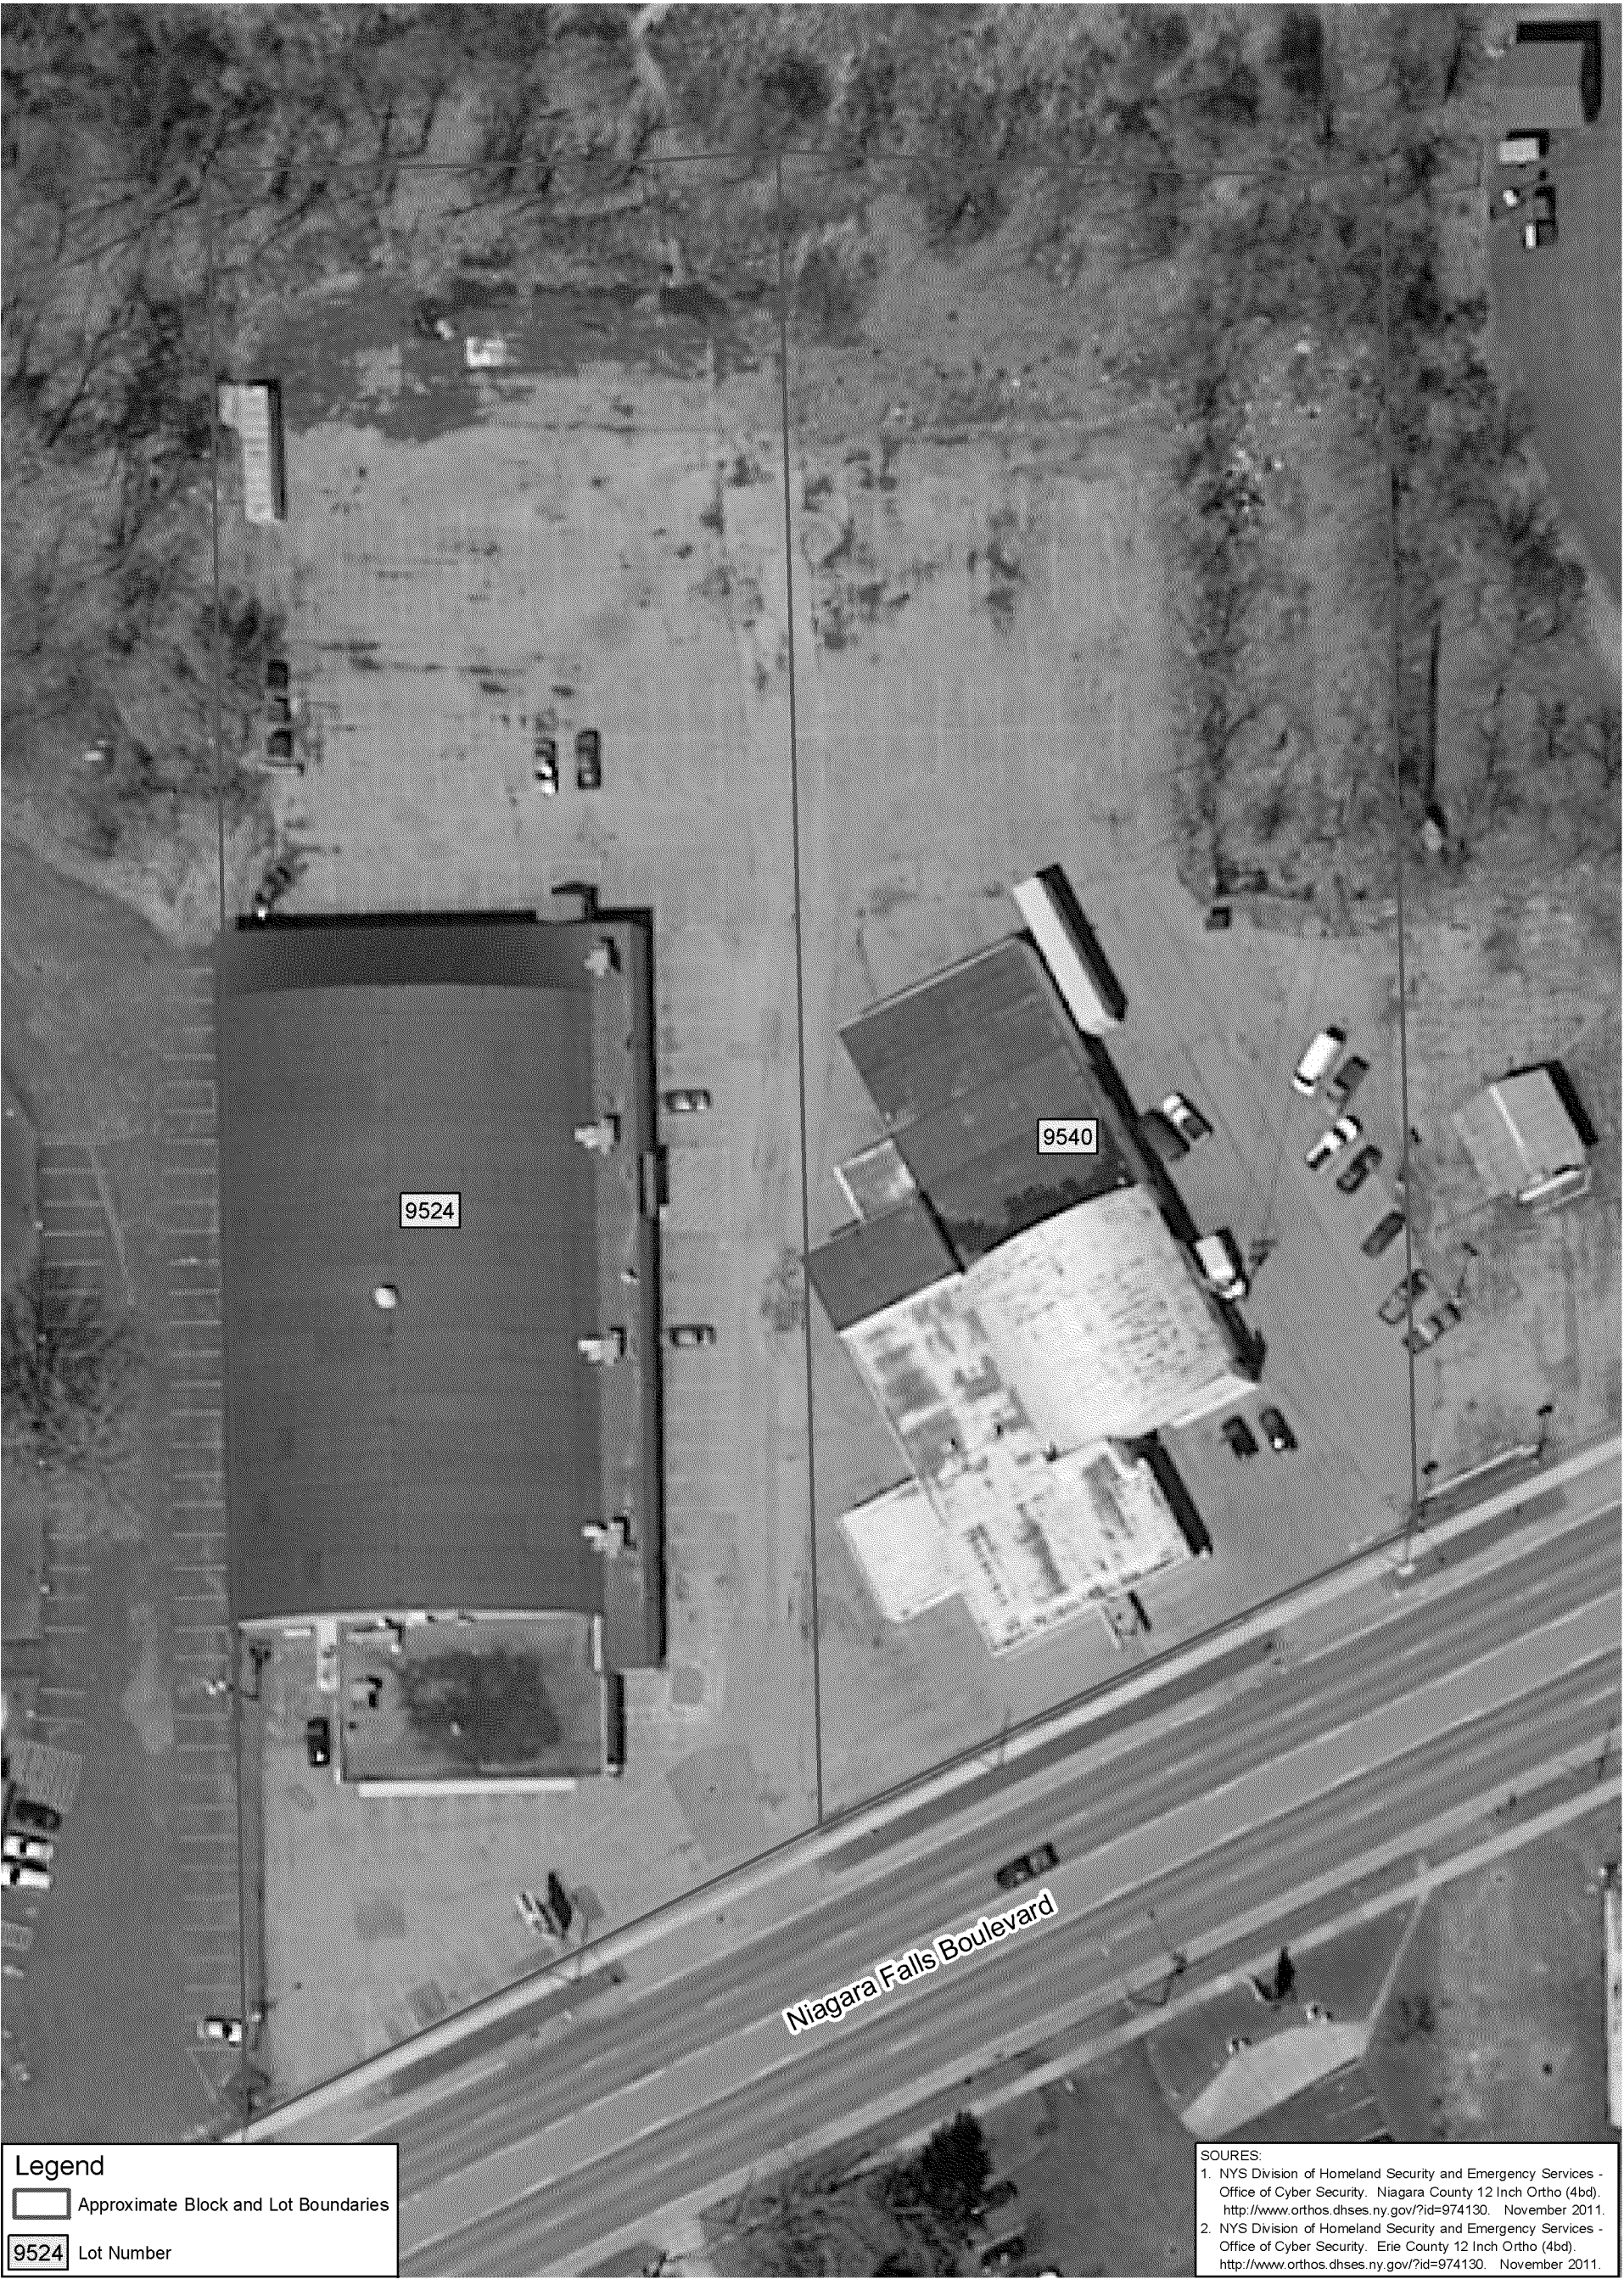
The 9540 Niagara Falls Boulevard site, hereinafter referred to as "the site", is located in a mixed commercial and residential area of Niagara Falls, New York, as shown on Figures 1 and 2 in the Appendix. The site consists of two parcels, namely 9524 and 9540 Niagara Falls Boulevard, and encompasses approximately 1 acre. Currently, the 9540 Niagara Falls Boulevard property contains a vacant building and an asphalt parking lot; the 9524 Niagara Falls Boulevard property contains a bowling alley and an asphalt parking lot. The properties are bordered to the north by a wooded area, to the east by a church, to the south by Niagara Falls Boulevard and a residential area, and to the west by a hotel and residential area.

Site Map  
Niagara Falls Boulevard  
Niagara Falls, NY

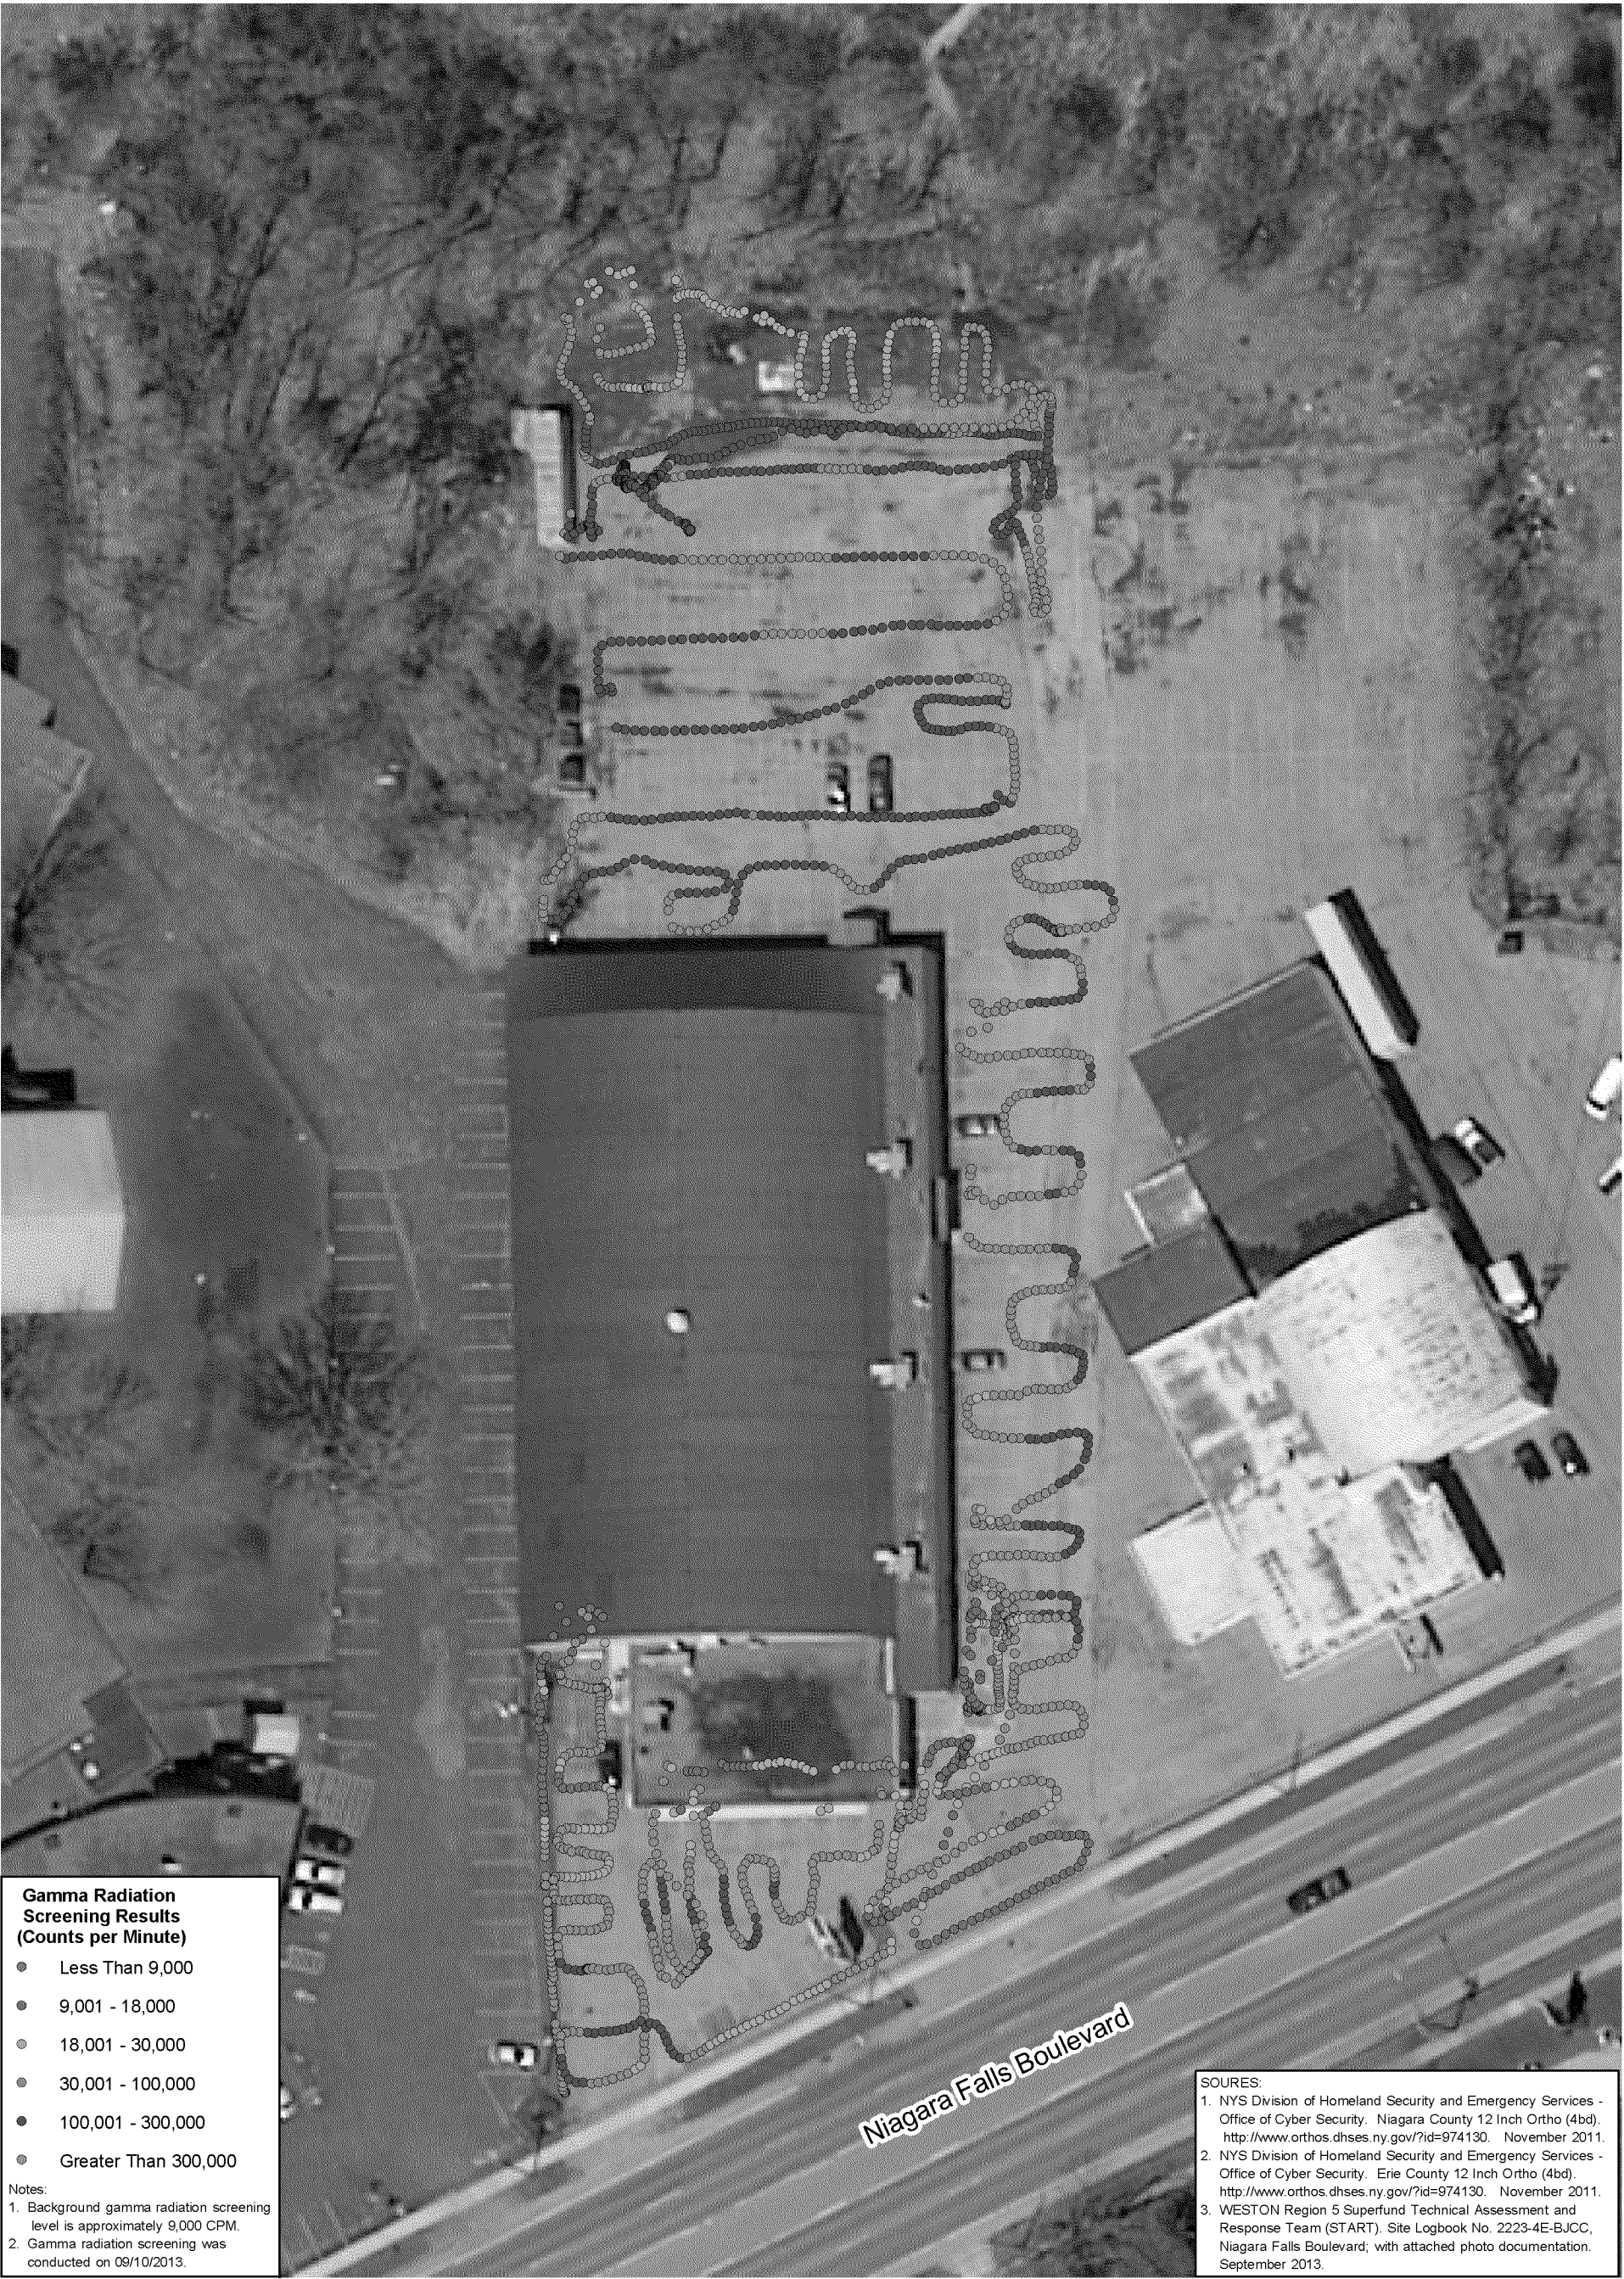
On September 10, 2013, WESTON conducted a radiological survey of the 9524 Niagara Falls Boulevard property using a Ludlum 2221 Scaler Ratemeter. [The property owner of 9540 Niagara Falls Boulevard did not grant access; therefore, the radiological survey did not include that property.] Beginning at the western corner of the property at Niagara Falls Boulevard and the adjacent hotel, WESTON began walking transects at 3-foot intervals measuring gamma radiation levels at waist height. Gamma readings along the grass swath between the 9524 Niagara Falls Boulevard property and the hotel property ranged from 20,000 to 30,000 cpm, and steadily increased to between 40,000 and 50,000 cpm as WESTON proceeded onto the asphalt. By the time WESTON reached the middle of the parking lot in front of the building, radiation levels were consistently over 100,000 cpm. Radiation levels measured on the concrete walkway directly in front of the building were generally below 20,000 cpm. Radiation levels detected while surveying the parking lot on the east side of the building adjacent to 9540 Niagara Falls Boulevard were consistently between 150,000 and 175,000 cpm, and the levels detected at the parking lot behind (i.e., north) of the building were consistently between 180,000 and 190,000 cpm. WESTON surveyed an area of broken asphalt in the rear parking lot; radiation levels ranged from 200,000 to 300,000 cpm. Radiation levels along the edge of the parking

lot and overgrown brush area behind the building ranged between 30,000 and 40,000 cpm. WESTON also surveyed gamma radiation levels inside the building. Radiation levels at the back entrance were around 25,000 cpm. Once inside the building, levels ranged between 6,000 and 10,000 cpm. The property owner stated that the whole back area (e.g., the lockers, arcade area, and small bowling store) was raised 2 feet with concrete, and that the radiation levels inside the building in this area were greatly reduced as a result. The storage area behind the alley registered levels between 7,000 and 8,000 cpm. The side entranceway, which also had additional concrete added, had radiation levels between 10,000 and 14,000 cpm. Figure 3 depicts the gamma radiation levels of the exterior portion of the property detected during the survey.
